# UH-1 ACCIDENT SUMMARY

Majors, Minors,  
Incidents,  
Forced Landings,  
Precautionary Landings

1 JULY 1960 THROUGH  
30 JUNE 1965

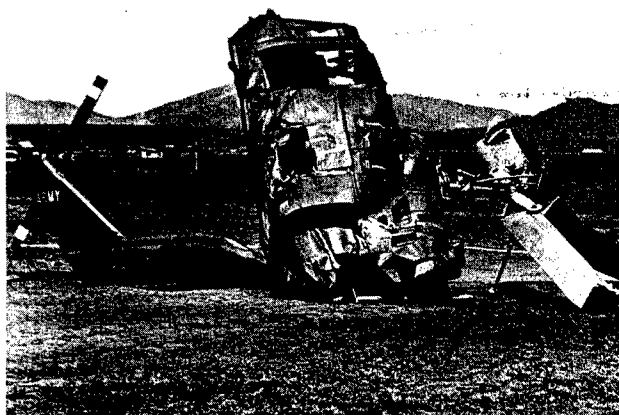
07747

throttle. Engine failed to respond and aircraft landed hard, bounced, and came to rest on right side. Loss of power caused by improper installation of support bearing on left end of throttle linkage torque tube. During installation of support bearing, retaining nut was screwed down too tight, shearing 3/32" rivet and pulling the shaft of torque tube to approximately half its normal engagement.

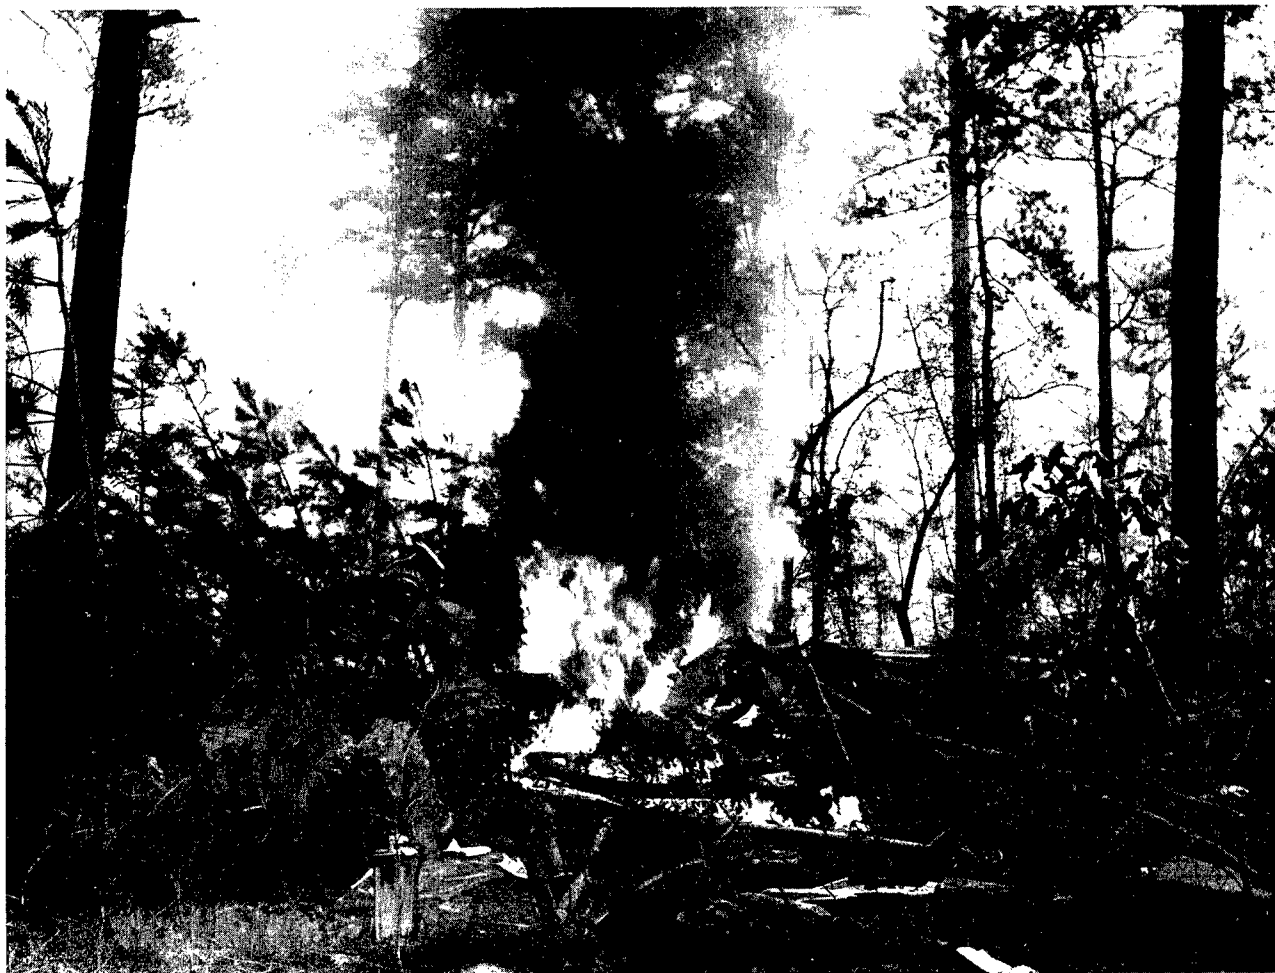
07441

**07441**--Aircraft crashed into trees and burned during attempted move through dense fog from one heliport to another. Pilot and crewchief killed. Caused by non-instrument rated pilot attempting flight with zero ceiling, totally obscured sky, and 1/16 mile visibility in fog. Crewchief was not wearing protective helmet or gloves.

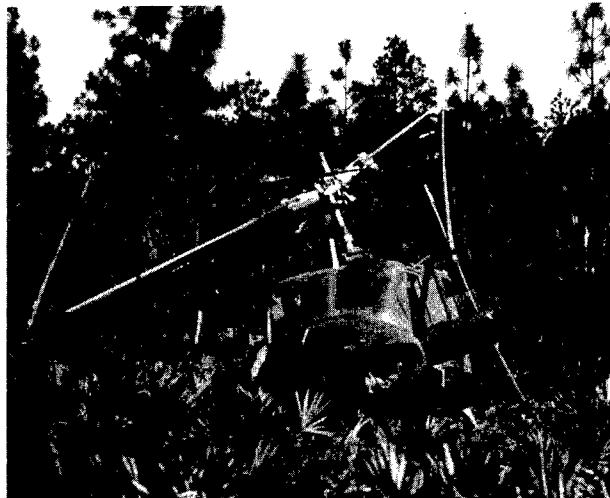
08295

**08295**--Pilot landed aircraft in confined area and picked up nine passengers during field exercise. Rotor rpm was lost during takeoff and main rotor blades struck trees. Aircraft landed hard, turning 180° to right. Crewchief and four passengers sustained scratches and bruises. Caused by assigning inexperienced pilot to mission beyond his capability, pairing inexperienced pilots, and exerting excessive command pressure on subordinate commanders to fly a maximum number of aircraft for a field exercise. Pilot had not completed transition checkout. Inadequate training of ground personnel resulted in selection of poor landing site.

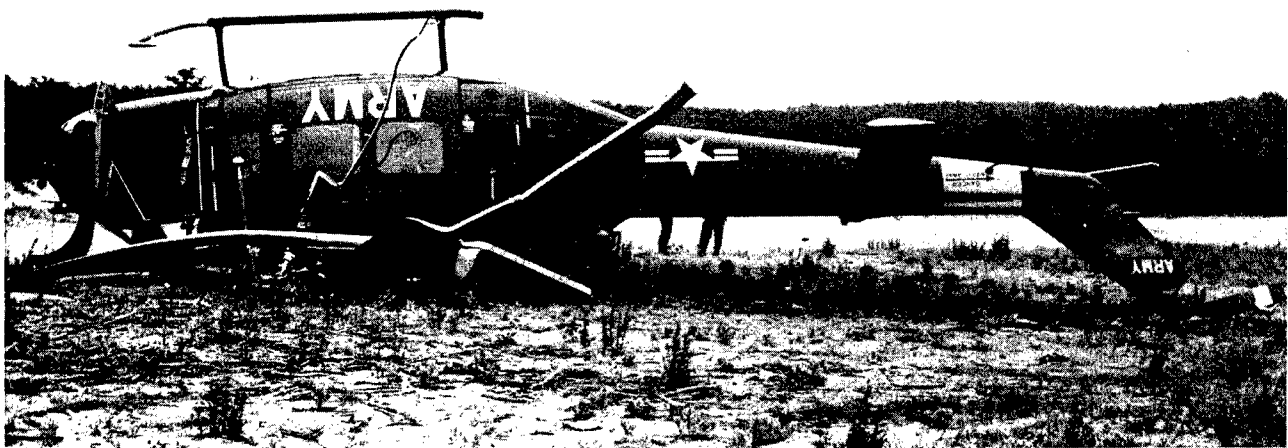
08371

**08371**--Aircraft drifted left, struck rise in ground, rolled, and came to rest inverted during attempted night landing from hover. Pilot, copilot, and two

passengers sustained minor injuries. Caused by loss of ground reference due to blowing dust. Heavy-left lateral CG due to seating of three passengers on left side and one on right was contributing factor. No ground guide was available.

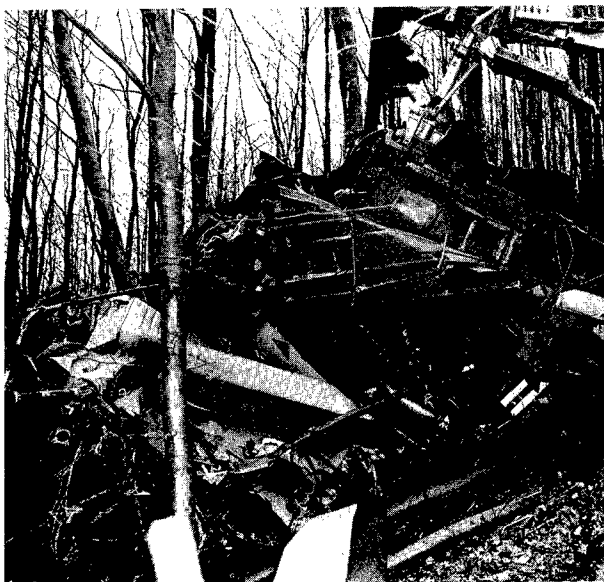
B813

**B813**--Aircraft flew into clouds and crashed on hillside approximately 2,400 feet above sea level. Pilot was killed and copilot seriously injured. Caused by attempting VFR flight in IFR weather. Contributing factors were: 1. Filing direct VFR flight plan into forecast instrument conditions. 2. Continued flight under weather conditions below authorized VFR minimums. 3. Low level flight under marginal weather conditions over mountainous terrain not familiar to pilots. 4. Flight into low ceiling and visibility conditions without appropriate reduction of airspeed. 5. Absence of IFR facilities at one station and inoperative VHF radio at another station influenced pilot's decision to proceed VFR. 6. False sense of urgency to complete mission contributed.

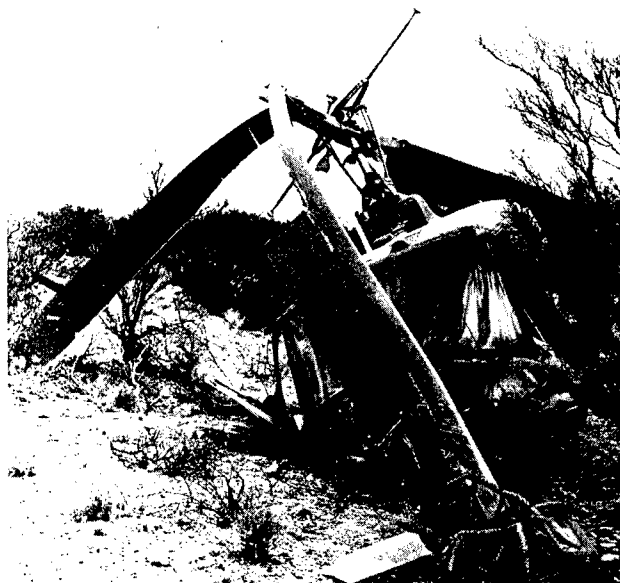
C058

**C058**--Severe vibration was followed by loud bang and loss of tail rotor control at 900 feet. Air-

craft hit on tail boom and right skid. Loss of tail rotor control caused by fatigue failure of bolt that connects pitch change link assembly to white tail rotor grip.
